## MIRIK MUNICIPALITY

### CONSTRUCTION SITE FIRST VISIT REPORT

First Visit : PROP-00401 - Construction of Public Toilet (PT) at Zambuling Gumba at Mirik Bazar .

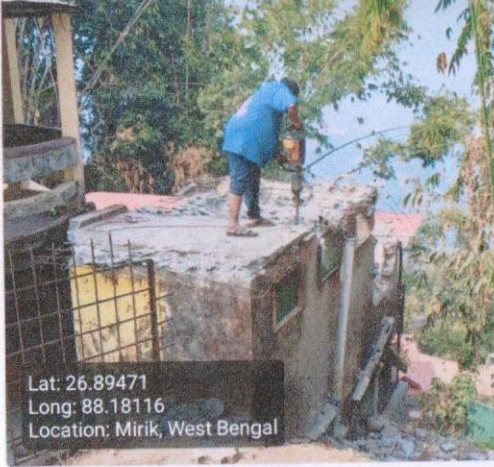
Visit Date	20/02/2026					
Earth Cutting (1200 x 1200 x 1000)	Column Nos.	Length (M)	Breath (M)	Height (M)	Status	Remarks
	10	1200	1200	1000	MISMATCH	Demolition of the old structure is difficult due to terrain conditions; therefore, foundation work has not been completed.

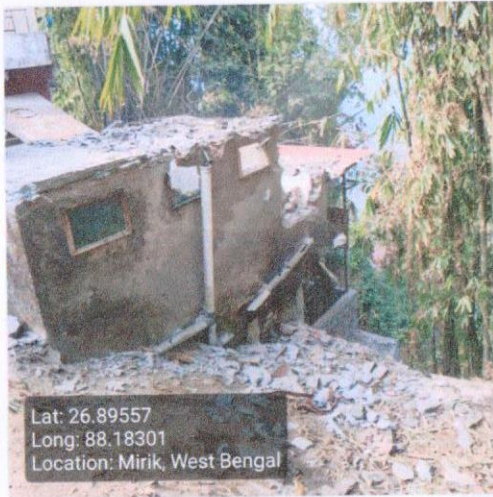
**Footing  
 Image**

Rod Nos.	Diameter (M)	Status	Remarks
10	10	MISMATCH	Footing parameter verification is not possible as the foundation work has not been completed.

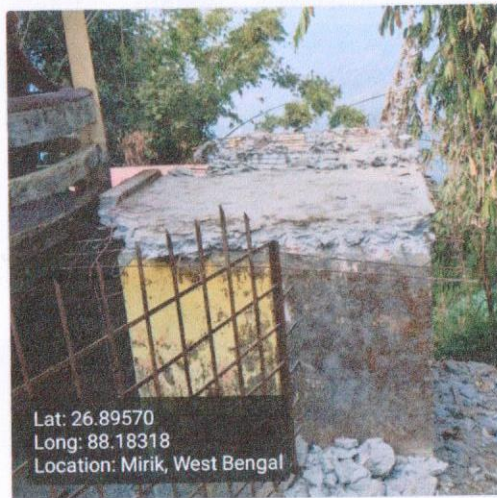
**Column  
 Image**

Rod Nos.	Diameter (M)	Length (M)	Height (M)	Status	Remarks
6	12	250	250	MISMATCH	Not completed.

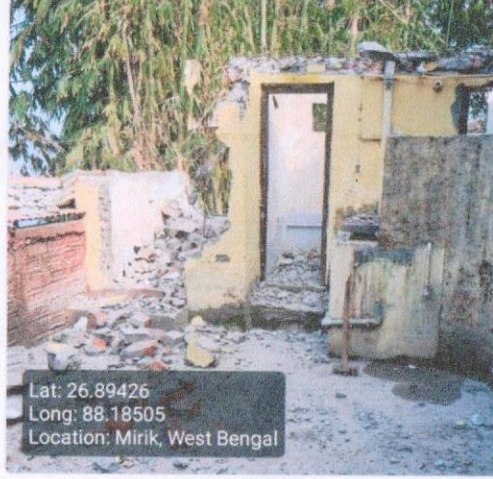
**Tie beam  
 (12 mm dia 4  
 nos)**

Rod Nos.	Diameter (M)	Length (M)	Breath (M)	Status	Remarks
4	12	250	250	MISMATCH	Not completed.

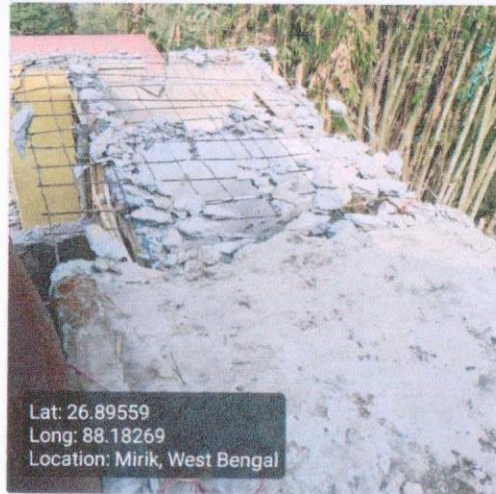
**Photo 1 - Angle 1**

Due to difficult terrain and land conditions, demolition of the old structure is challenging. The ULB initially faced some confusion regarding the site, resulting in a delayed start of demolition work. However, after consultation with us, the work is now in progress. The IFA is awaiting completion of the demolition work and progress up to the foundation level. Upon reaching the foundation level, parameter verification will be carried out at the 1st construction stage.
