KALIMPONG MUNICIPALITY

CONSTRUCTION SITE SECOND VISIT REPORT

Second Visit : PROP-00746 - INDUSTRIAL PARK (FIRST FLOOR)

Construction Site Second Visit Report

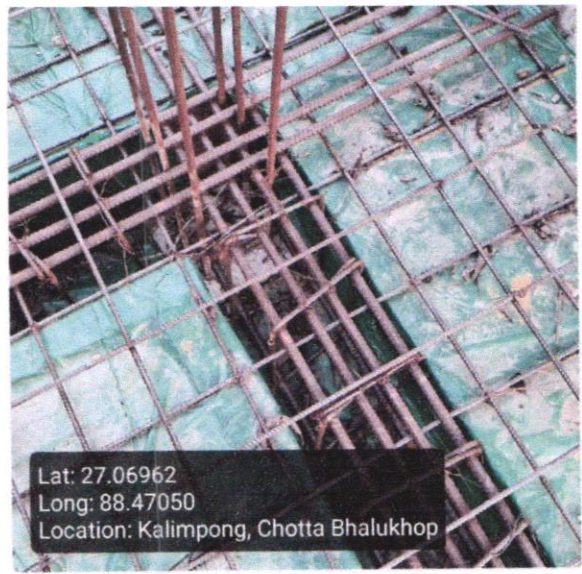
Roof Beam Top Support Image

Roof Beam Top Support
(16 mm dia, 4 nos.)

Rod Nos.	Diameter (mm)	Status	Remarks
4	16	OK	OK

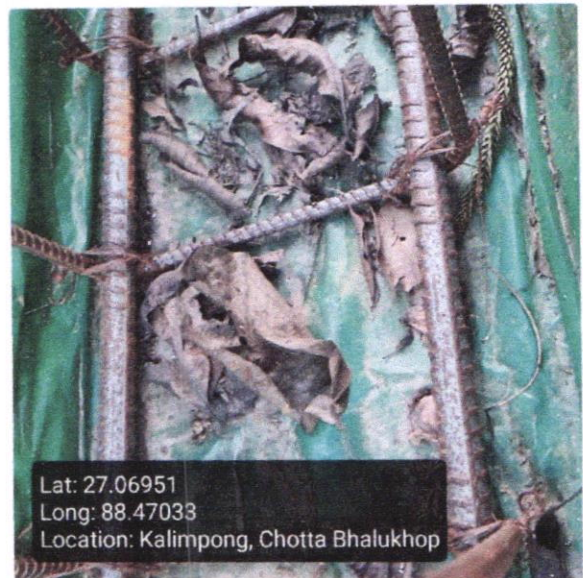
Roof Beam Bottom Support Image

**Roof Beam Bottom Support
(16 mm dia, 2 nos.)**

Rod Nos.	Diameter (mm)	Status	Remarks
2	16	OK	OK

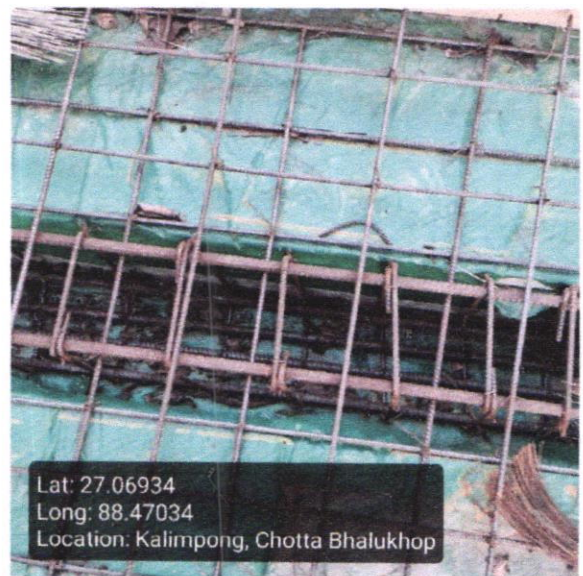
Roof Beam Mid Span Top Support Image

**Roof Beam Mid Span Top Support
(16 mm dia 2 nos)**

Rod Nos.	Diameter (mm)	Status	Remarks
2	16	OK	OK

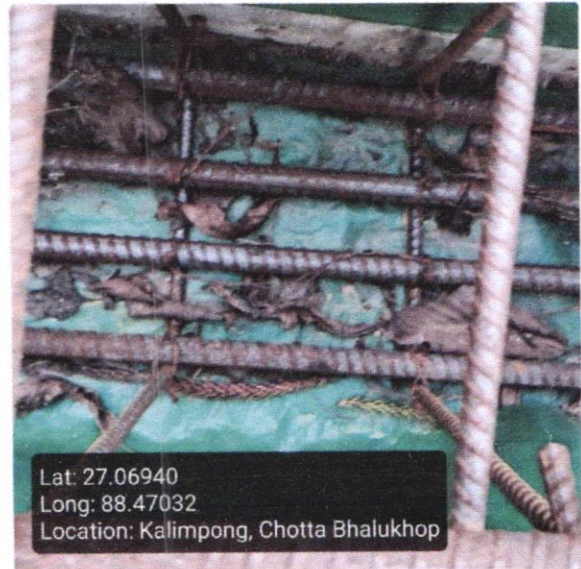
Roof Beam Mid Span Bottom Support Image

Roof Beam Mid Span Bottom Support
(16 mm dia 4 nos)

Rod Nos.	Diameter (mm)	Status	Remarks
4	16	OK	OK

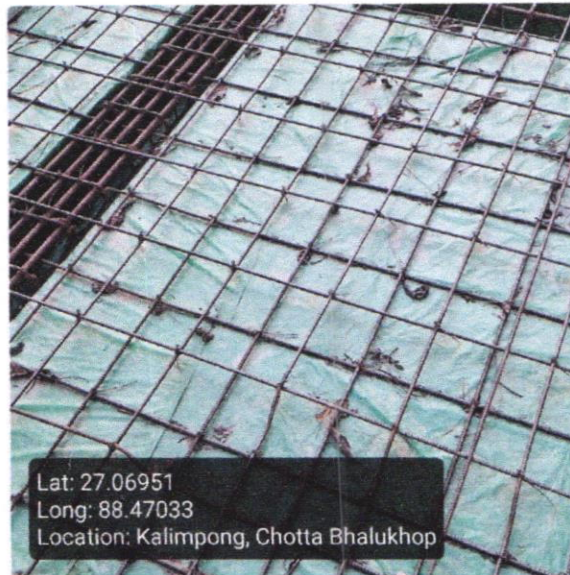
Roof Details Parameters Image

Roof Details Parameters
(8 mm dia 125 nos)

Diameter (mm)	Depth (mm)	Status	Remarks
8	125	OK	OK

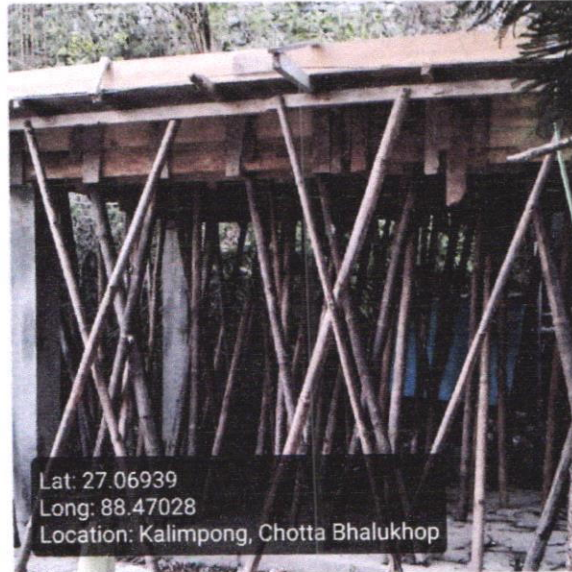
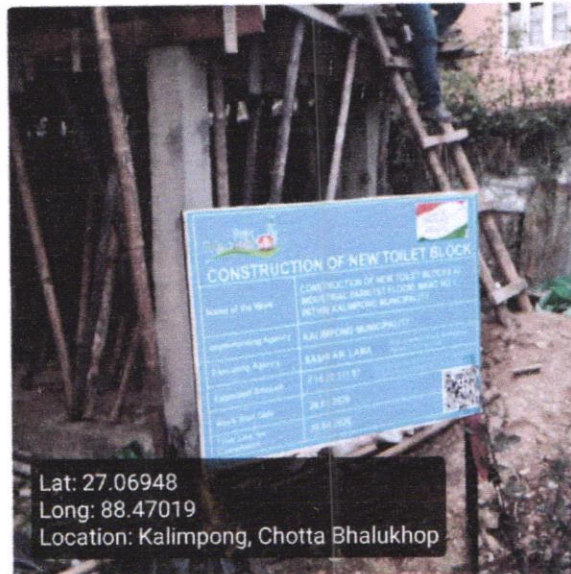
All reinforcement parameters are found to be satisfactory; however, the shuttering is not level. The ULB Engineer has been advised to ensure proper leveling of the shuttering prior to casting.
