KALIMPONG MUNICIPALITY

CONSTRUCTION SITE SECOND VISIT REPORT

Second Visit : PROP-00747 - DISTRICT HOSPITAL, BEHIND OLD OFFICE UNIT 1

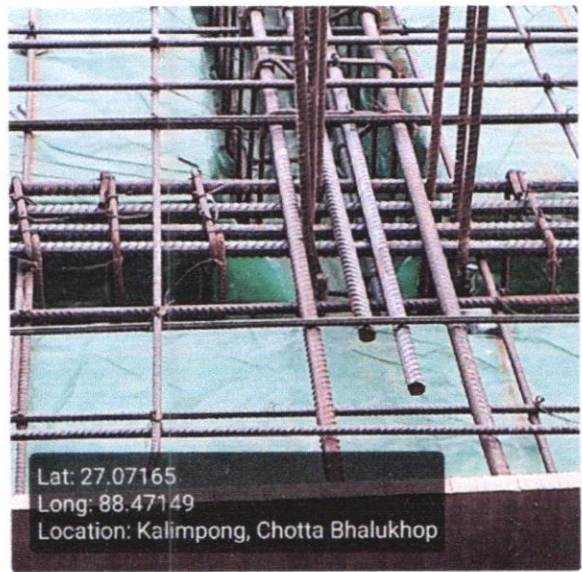
Roof Beam Top Support Image

Visit Date	06/04/2026			
Roof Beam Top Support (16 mm dia, 4 nos.)	Rod Nos.	Diameter (mm)	Status	Remarks
	4	16	OK	OK

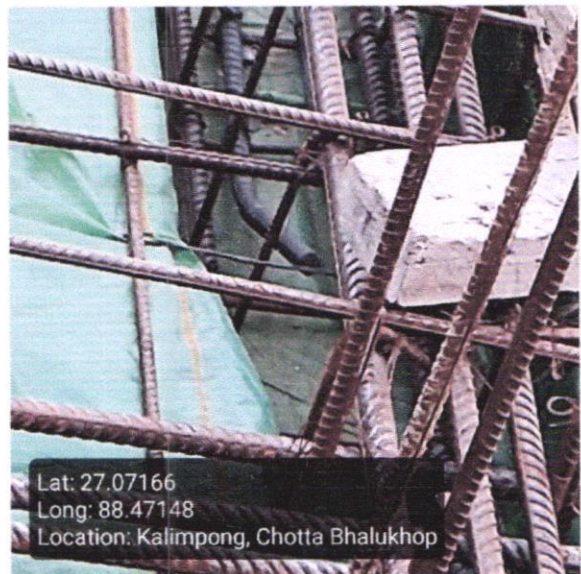
Roof Beam Bottom Support Image

**Roof Beam Bottom Support
(16 mm dia, 2 nos.)**

Rod Nos.	Diameter (mm)	Status	Remarks
2	16	OK	OK

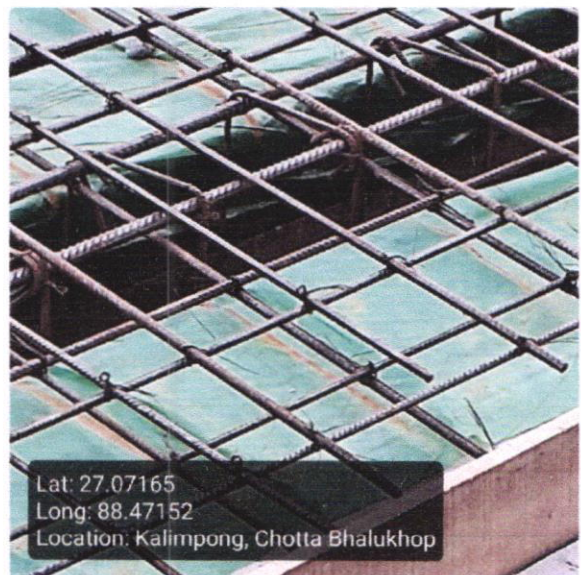
Roof Beam Mid Span Top Support Image

**Roof Beam Mid Span Top Support
(16 mm dia 2 nos)**

Rod Nos.	Diameter (mm)	Status	Remarks
2	16	OK	OK

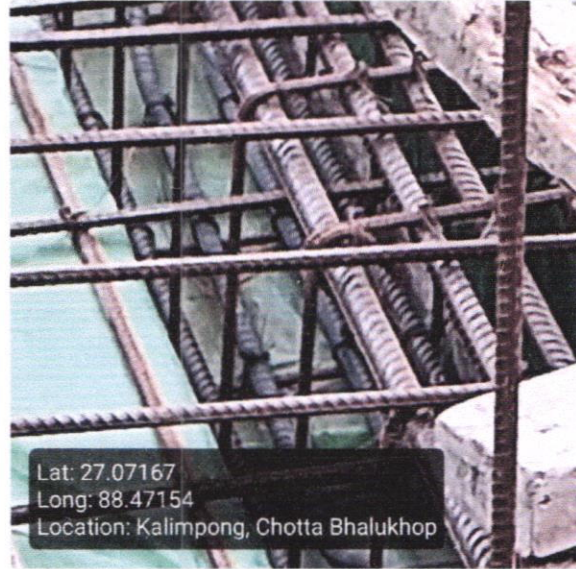
Roof Beam Mid Span Bottom Support Image

Roof Beam Mid Span Bottom Support
(16 mm dia 4 nos)

Rod Nos.	Diameter (mm)	Status	Remarks
4	16	OK	OK

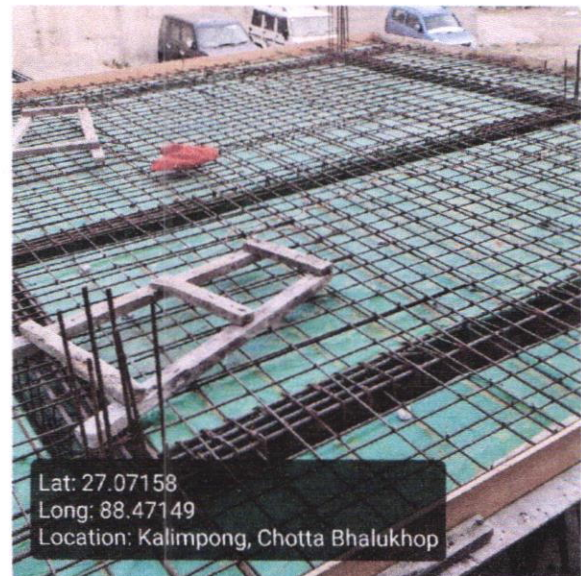
Roof Details Parameters Image

Roof Details Parameters
(8 mm dia 125 nos)

Diameter (mm)	Depth (mm)	Status	Remarks
8	125	OK	OK

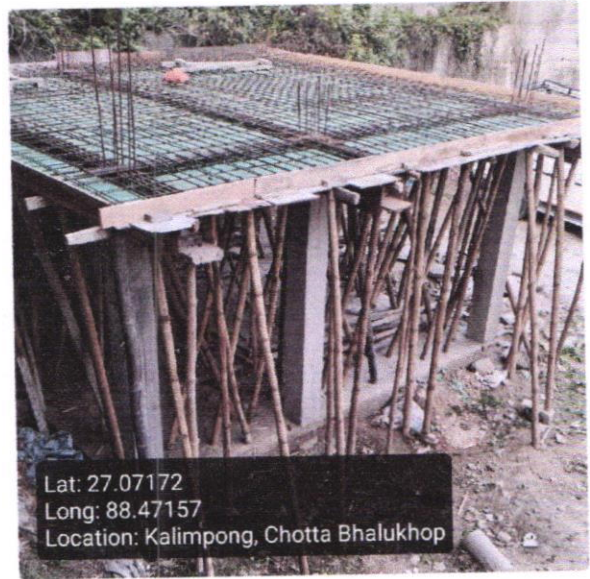
Photo 1 - Angle 1

Ok
