TUFANGANJ MUNICIPALITY
CONSTRUCTION SITE SECOND VISIT REPORT

Second Visit : PROP-01018 - Tufanganj Municipality no 1 primary school

Construction Site Second Visit Report

At the time of Roof Casting - Visit Details

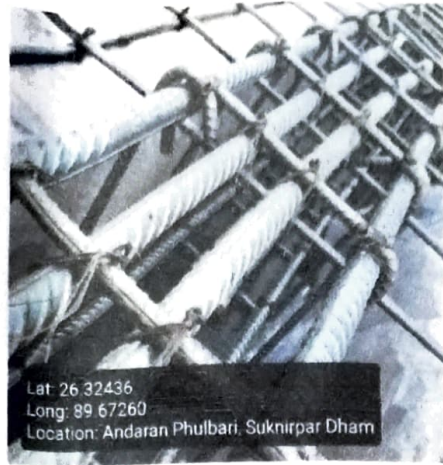
Roof Beam Top Support Image

Visit Date	31/03/2026			
Roof Beam Top Support (16 mm dia, 4 nos.)	Rod Nos.	Diameter (mm)	Status	Remarks
	4	16	OK	OK

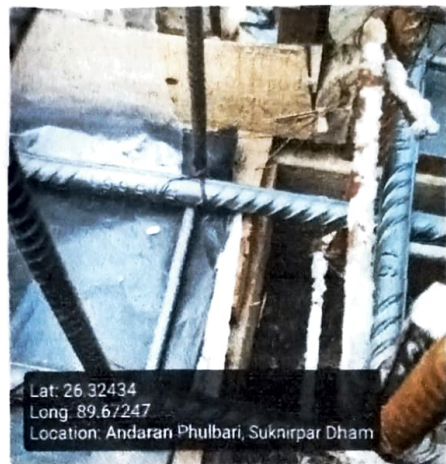
Roof Beam Bottom Support Image

Roof Beam Bottom Support
(16 mm dia, 2 nos.)

Rod Nos.	Diameter (mm)	Status	Remarks
2	16	OK	OK

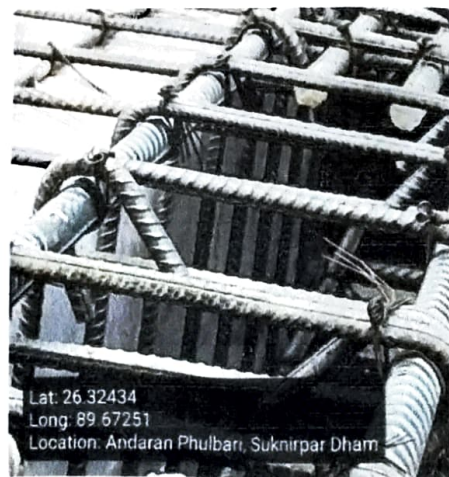
Roof Beam Mid Span Top Support Image

Roof Beam Mid Span Top Support
(16 mm dia 2 nos)

Rod Nos.	Diameter (mm)	Status	Remarks
2	16	OK	OK

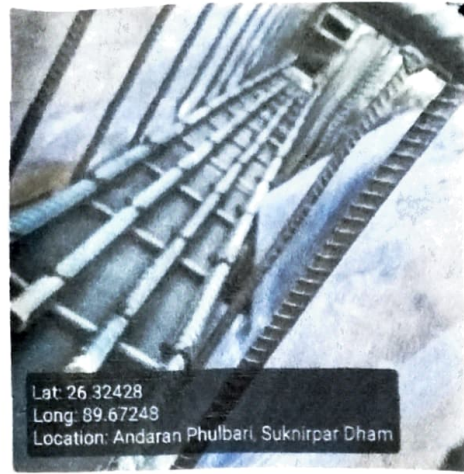
Roof Beam Mid Span Bottom Support Image

Roof Beam Mid Span Bottom Support
(16 mm dia 4 nos)

Rod Nos.	Diameter (mm)	Status	Remarks
4	16	OK	OK

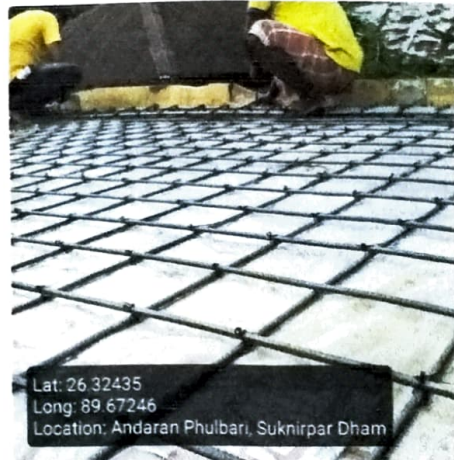
Roof Details Parameters Image

Roof Details Parameters
(8 mm dia 125 nos)

Diameter (mm)	Depth (mm)	Status	Remarks
8	125	OK	OK
