DINHATA MUNICIPALITY
CONSTRUCTION SITE SECOND VISIT REPORT

Second Visit : PROP-00273 - CHILDREEN PARK

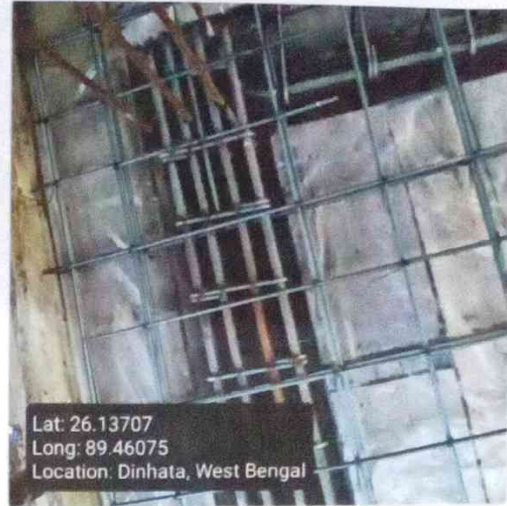
Roof Beam Top Support Image

Visit Date	17/01/2026			
Roof Beam Top Support (16 mm dia, 4 nos.)	Rod Nos.	Diameter (mm)	Status	Remarks
	4	16	OK	OK

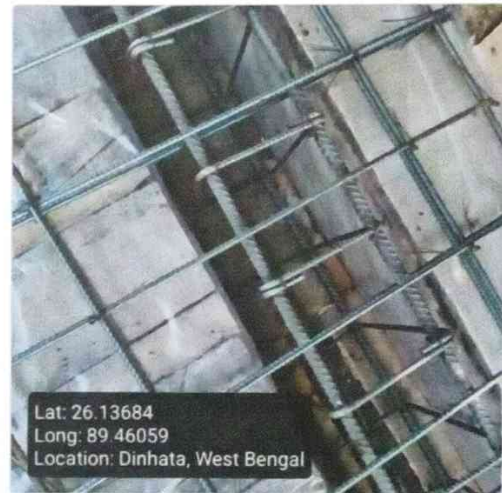
Roof Beam Bottom Support Image

Roof Beam Bottom Support
(16 mm dia, 2 nos.)

Rod Nos.	Diameter (mm)	Status	Remarks
2	16	OK	OK

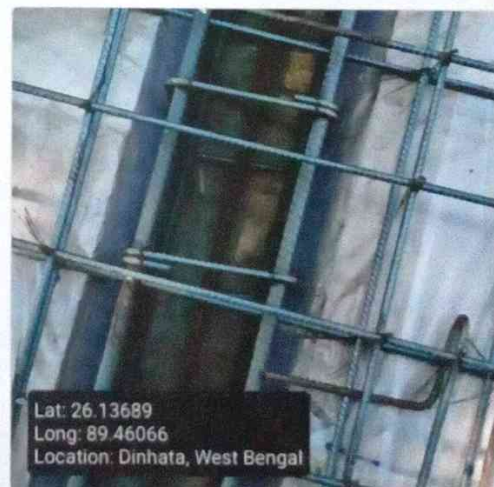
Roof Beam Mid Span Top Support Image

Roof Beam Mid Span Top Support
(16 mm dia 2 nos)

Rod Nos.	Diameter (mm)	Status	Remarks
2	16	OK	OK

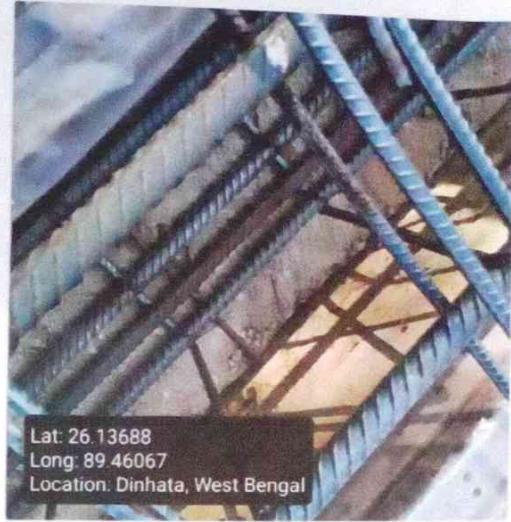
Roof Beam Mid Span Bottom Support Image

Roof Beam Mid Span Bottom Support
(16 mm dia 4 nos)

Rod Nos.	Diameter (mm)	Status	Remarks
4	16	OK	OK

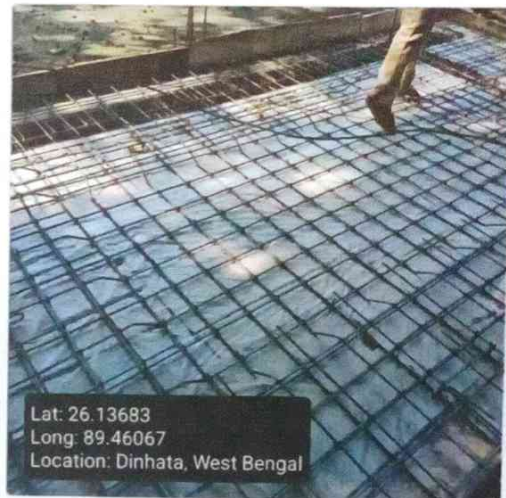
Roof Details Parameters Image

Roof Details Parameters
(8 mm dia 125 nos)

Diameter (mm)	Depth (mm)	Status	Remarks
8	125	OK	OK

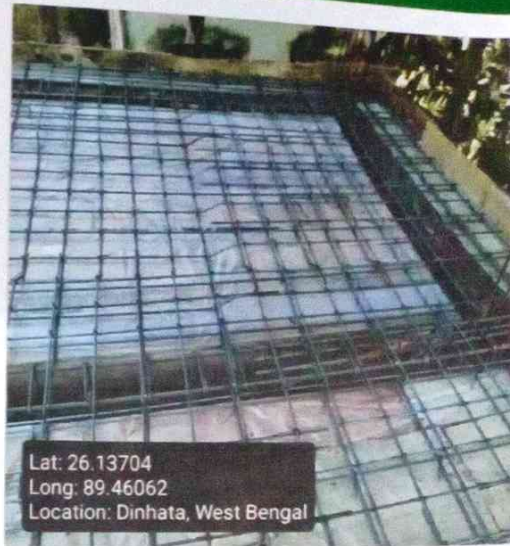
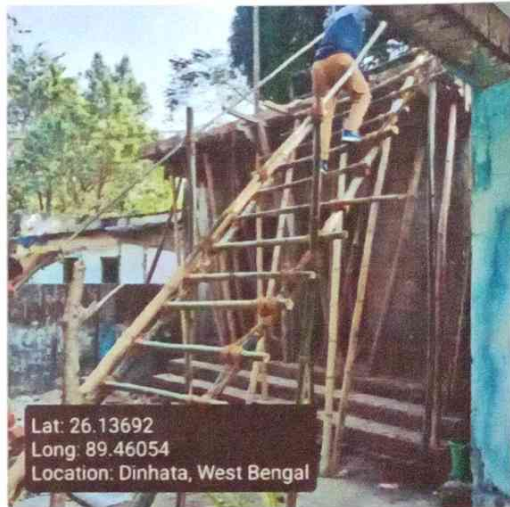
Overall Work Status - Images

Ok
