ENGLISH BAZAR MUNICIPALITY
CONSTRUCTION SITE SECOND VISIT REPORT

Second Visit | PROP-00495 - A C Institution block 1

At the time of Roof Casting - Visit Details

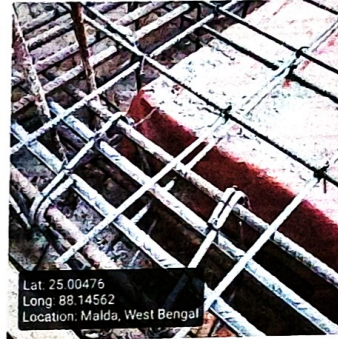
Roof Beam Top Support Image

Roof Beam Top Support
(16 mm dia, 4 nos.)

| Rod Nos. | Diameter (mm) | Status | Remarks |
|---|---|---|---|
| 4 | 16 | OK | OK |

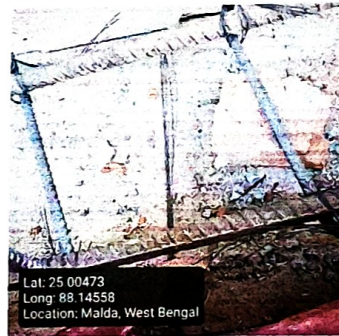
Roof Beam Bottom Support Image

Roof Beam Bottom Support
(16 mm dia, 2 nos.)

| Rod Nos. | Diameter (mm) | Status | Remarks |
|---|---|---|---|
| 2 | 16 | OK | OK |

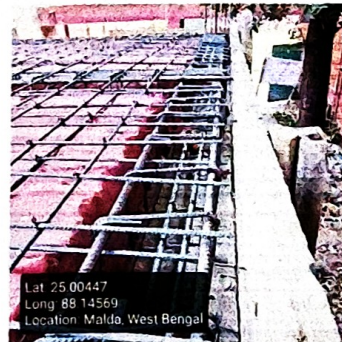
Roof Beam Mid Span Top Support Image

Roof Beam Mid Span Top Support
(16 mm dia 2 nos)

| Rod Nos. | Diameter (mm) | Status | Remarks |
|---|---|---|---|
| 2 | 16 | OK | OK |

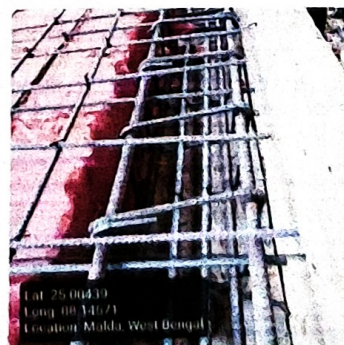
Roof Beam Mid Span Bottom Support Image

Roof Beam Mid Span Bottom Support
(16 mm dia 4 nos)

| Rod Nos. | Diameter (mm) | Status | Remarks |
|---|---|---|---|
| 4 | 16 | OK | OK |

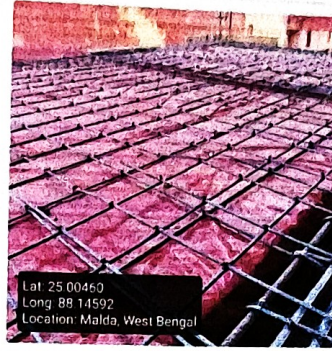
Roof Details Parameters
(8 mm dia 125 nos)

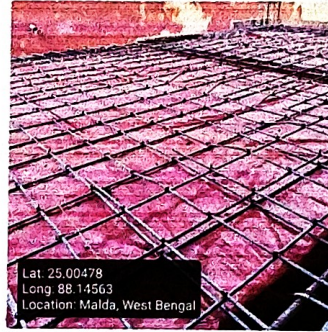
Photo 1 - Angle 1

The brickwork between the lintel level and the rooftop has not been executed as per specifications and requires rectification.
