KALIMPONG MUNICIPALITY

CONSTRUCTION SITE SECOND VISIT REPORT

Second Visit : PROP-00751 - PRANAMI BALIKA BIDHYA MANDIR

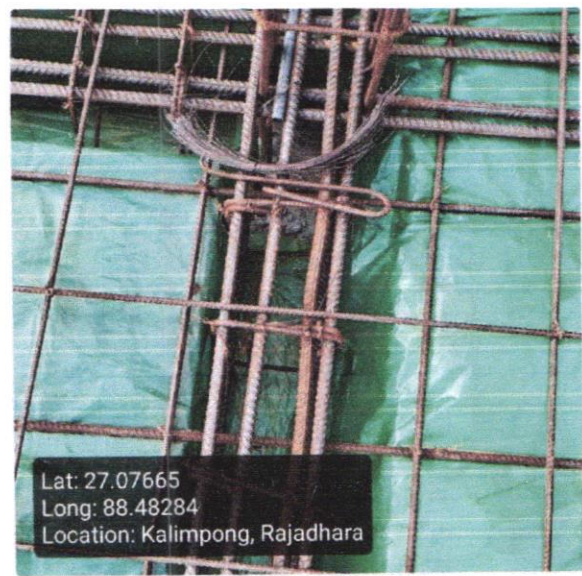
Roof Beam Top Support Image

Visit Date	06/04/2026			
Roof Beam Top Support (16 mm dia, 4 nos.)	Rod Nos.	Diameter (mm)	Status	Remarks
	4	16	OK	OK

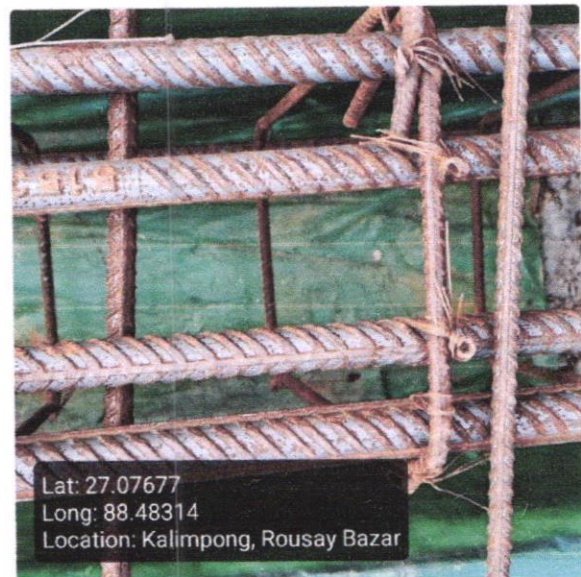
Roof Beam Bottom Support Image

**Roof Beam Bottom Support
(16 mm dia, 2 nos.)**

Rod Nos.	Diameter (mm)	Status	Remarks
2	16	OK	OK

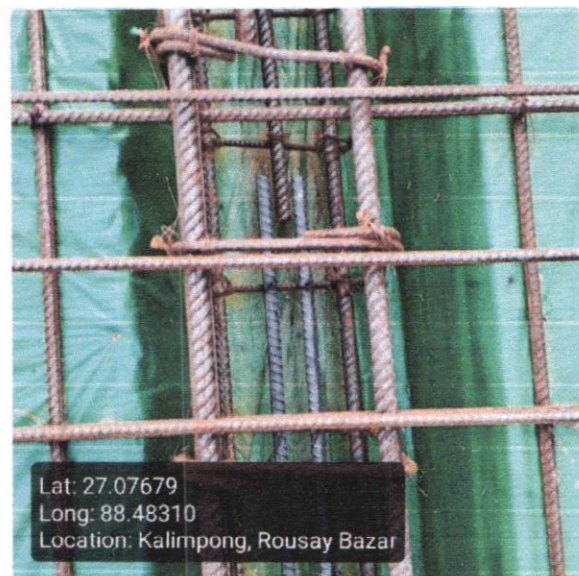
Roof Beam Mid Span Top Support Image

**Roof Beam Mid Span Top Support
(16 mm dia 2 nos)**

Rod Nos.	Diameter (mm)	Status	Remarks
2	16	OK	OK

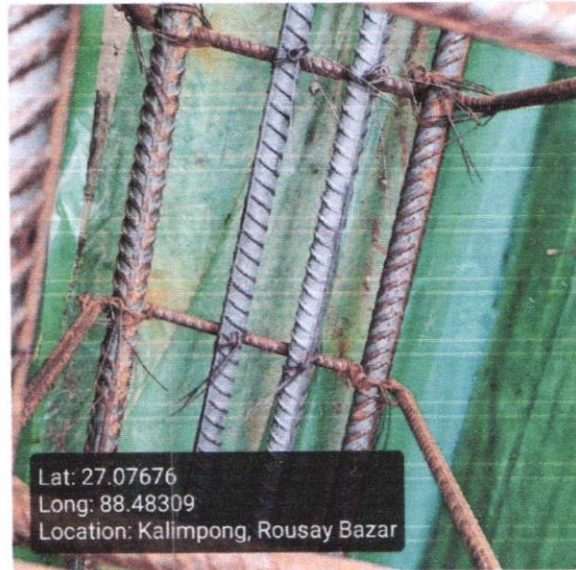
Roof Beam Mid Span Bottom Support Image

**Roof Beam Mid Span Bottom Support
(16 mm dia 4 nos)**

Rod Nos.	Diameter (mm)	Status	Remarks
4	16	OK	OK

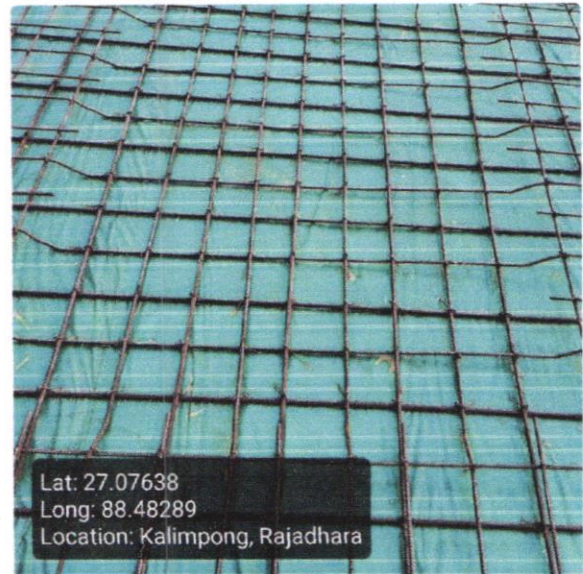
Roof Details Parameters Image

**Roof Details Parameters
(8 mm dia 125 nos)**

Diameter (mm)	Depth (mm)	Status	Remarks
8	125	OK	OK

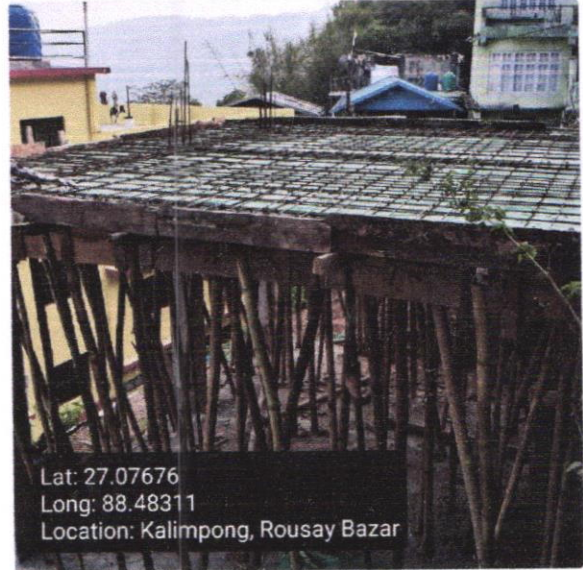
Photo 1 - Angle 1

Ok
